**mcHF Hardware modifications as of April 29, 2015
as compiled by KA7OEI for
Version 0.3/4 UI and Version 0.4 RF boards**

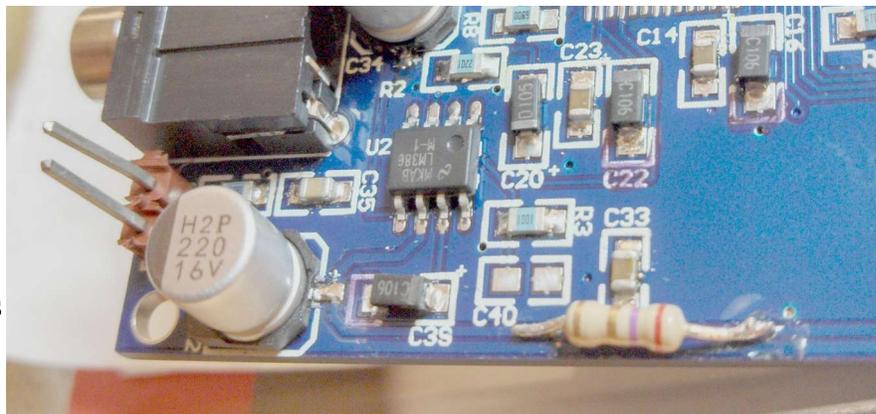
The 4.7 ohm resistor added to the UI_8V line feeding U2, the audio amplifier.

This modification prevents audio from appearing on the 8 volt line which, in turn, causes audio to appear on the ground busses and other power supplies in the radio which can cause feedback, particularly at high volume levels with wider audio filters.

The insertion of a 4.7 ohm, 1/2 watt resistor in series (or two 10 ohm 1/8 watt resistors in parallel) with the +8 volt line, near the LM386 audio amplifier.

If this describes what is happening to you, this fix is also quite simple: Increase the capacitance at C32. It has been found that adding another 1000 uF of capacitance across C32 seems to prevent audio feedback, having done all of the other modifications.

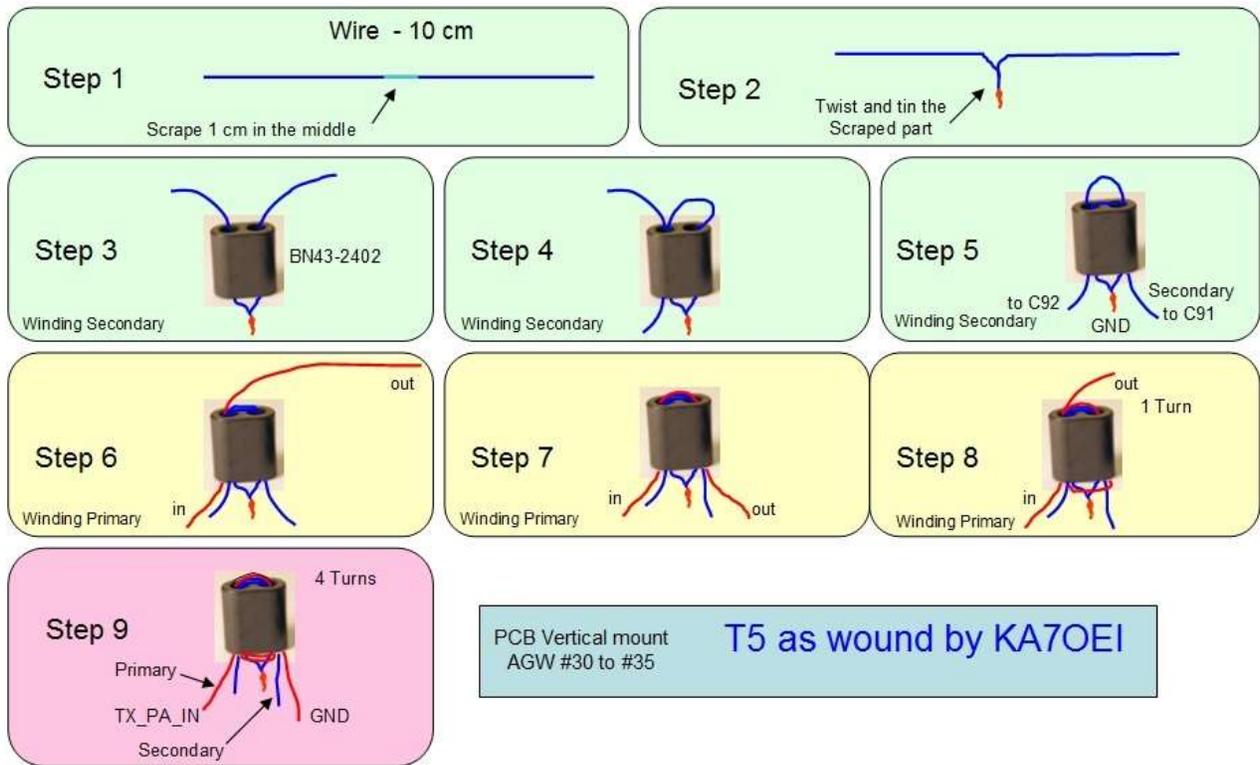
Step-by-step winding guide for constructing "T5"

The original part number for transformer T5 on the RF board called for a 1:4(CT) transformer, but a circuit analysis will indicate that this is inappropriate for the impedance of Q4/Q5, the RF Driver transistors. The current BOM calls for a 1:1(CT) transformer – a “less bad” match, but still not ideal in that there is a mismatch causing ripple/loss in the bandpass filters but it is less severe than with the original 1:4 impedance.

A better transformer would be a 4:1(CT) transformer. Unfortunately, one cannot simply turn the original transformer “backwards” since it lacks a centertap on the necessary side in order to properly drive Q4/Q5. Fortunately, it is easy to wind a custom transformer using a BN43-2402 core – the very same core used for RFC8 – and some small-diameter wire.

This reworked transformer is small enough to be soldered to the original pads occupied by T5: Just make the leads as short as practical.

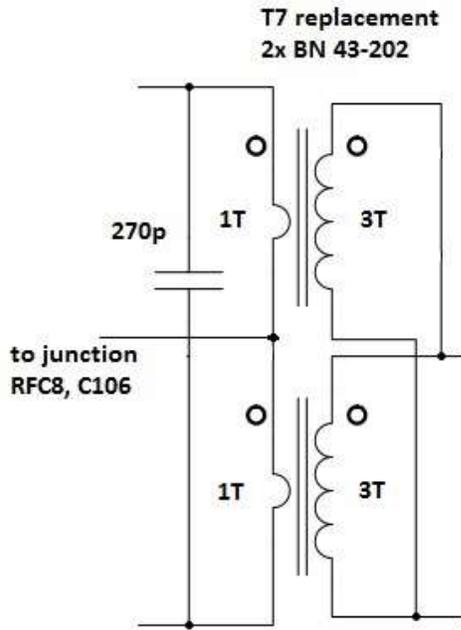
Wiring diagram of T7

As it turns out there has been quite a bit of discussion related to the ability (or inability) experienced by some users of the mcHF to output a “solid” 5 watts on higher bands. Careful analysis by some of the folks on the Yahoo group has shown that the original transformer design suffers from a few design deficits, namely:

- Primary/Secondary coupling not as tight as it should be
- Excessive leakage inductance
- Transformation ratio not optimal for maximum power output at good efficiency
- Reactance of transformer not compensated

The schematic diagram of the new transformer is depicted to the left.

The drawing depicts two identical transformers sharing a “primary”, center-tapped winding and paralleled secondary with a 270 pF capacitor (*rated for 200 volts or more*) connected across the primary to compensate for the reactance and improve performance.

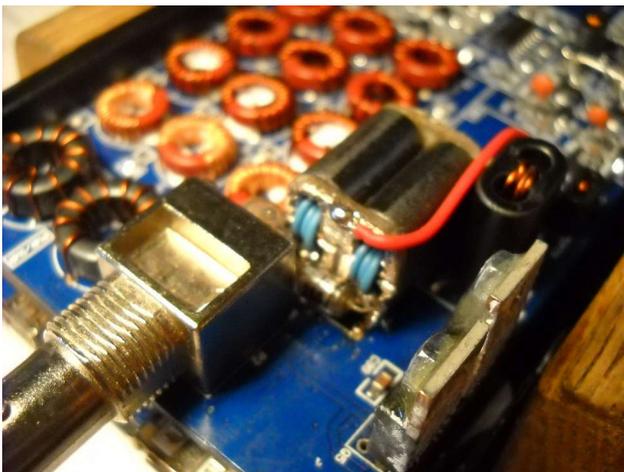
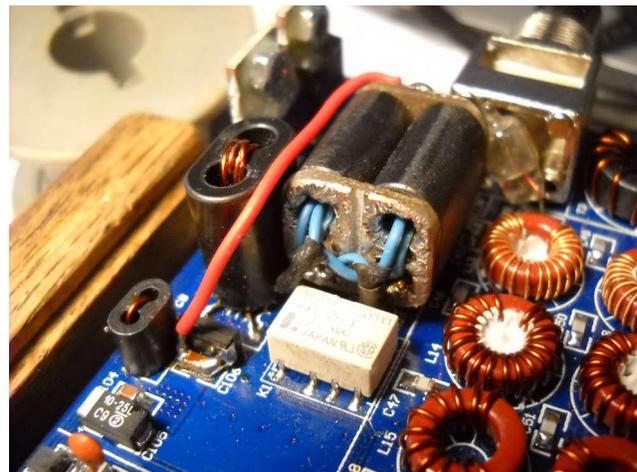
Photographs of the completed T7. On the left can be seen the 270 pF capacitor across the primary of the transformer while on the right can be seen the connection to the output of the secondary winding.

If one looks closely at the above pictures it can also be seen that on the “center-tapped” side of the primary (the left-hand photograph) a piece of copper-clad printed circuit board is used to connect the primary windings (the coax braid) inside each core together. While this makes for a very neat construction, it is not absolutely necessary, but if flat, copper material – such as PCB material or copper sheeting/flushing – is not used it is recommended that multiple strands of bare, copper wire be used to bond them together.

Finally, although not shown on the schematic or visible in the left-hand photograph, it is recommended that a 0.1uF capacitor be connected between ground and where the V+ (red wire in the photograph) is connected on the two cores for optimal RF bypassing.

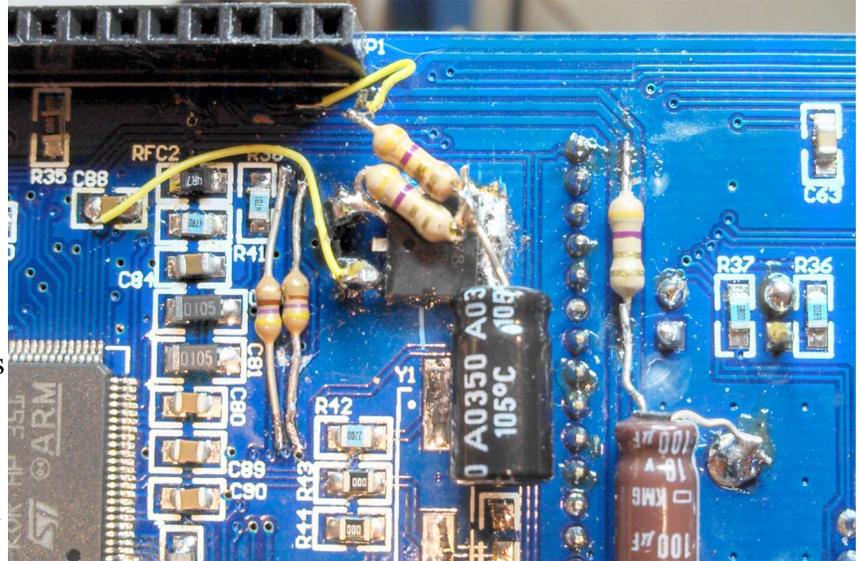
With the increase in sensitivity due to the reduced receiver background noise there may be the additional tendency for audio feedback to occur at high volume levels, particularly with no antenna connected *when using a speaker*. This is related to circulating currents on the UI board, some of which were addressed with the addition of the 4.7 ohm resistor in series with the 8 volt line on U2 noted earlier in this document.

Increasing the capacitance of C32 to filtering and the additional filtering of the 5 volt LCD line (right). 1000uF can reduce this effect, as *The resistor to filter the "tick" (see next section) are also visible.* can the use of headphones or an external audio amplifier.

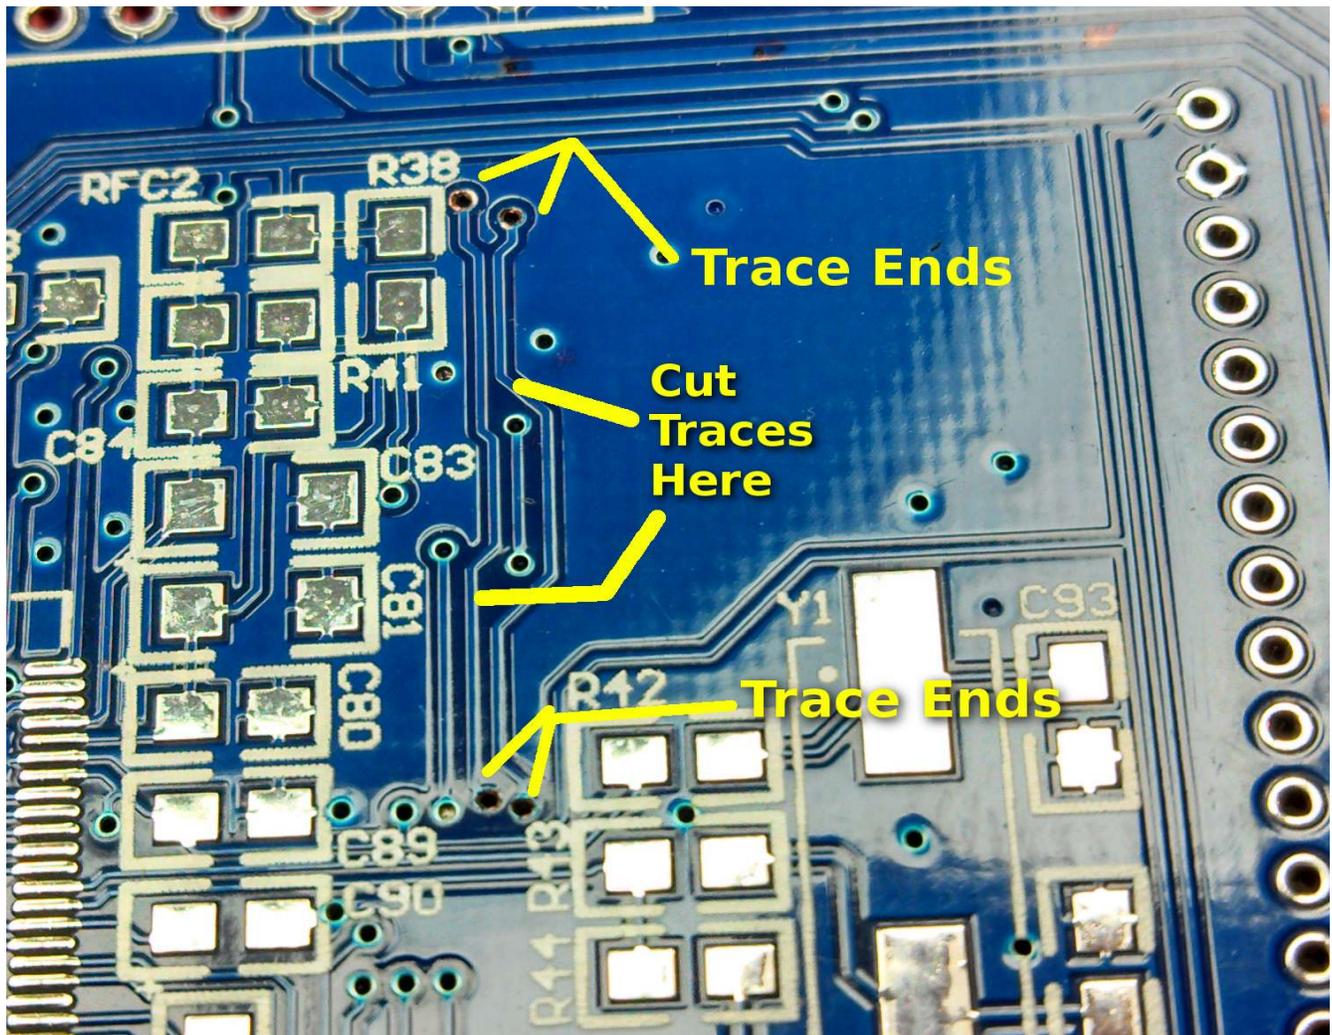
If the above modifications are made, with no antenna connected – or even with an antenna connected when listening on higher bands (especially 20 meters and above) a fairly strong “tick” may be heard every second. This is due to the polling of the onboard temperature sensor and the fact that the “fall” time of the on the I2C line from the MCU is extremely fast and rich with harmonic energy. This problem can be easily “fixed” with the addition of resistors on the UI board in series with the SCL and SDA lines which effectively reduce the slew rate of these lines, quashing the RF energy.

This picture shows the location of the traces and where the cuts should be made. This is found to the right and above U4a, the MCU. A picture of a “bare” board is used for clarity.

A reasonable value of resistor to install is 470 ohms and the installed components may be seen in the picture.

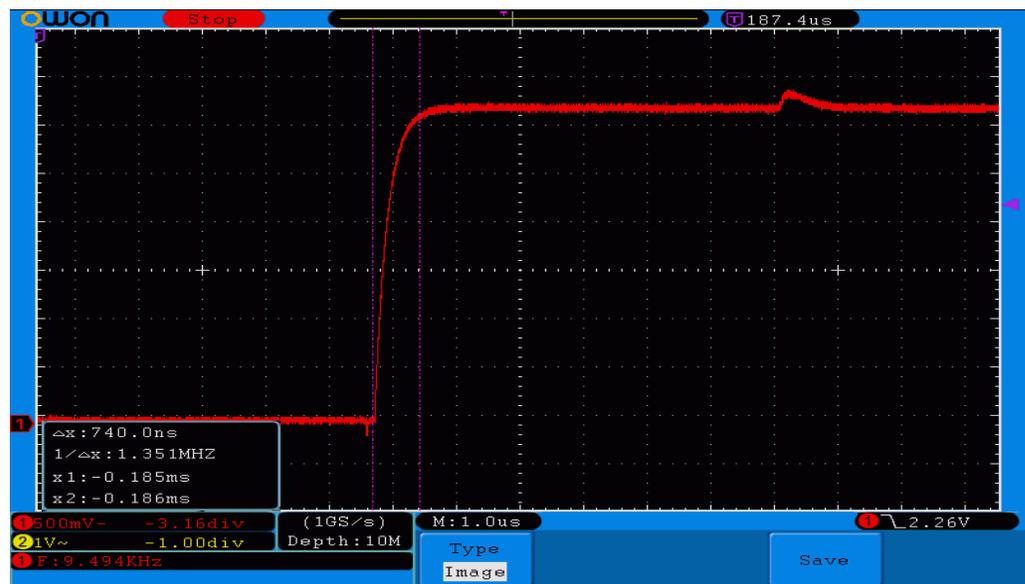
As can be seen, the risetime is less than 740 ns at the 10%-90% points which is a fraction of the I2C clocking rate, well within the time at which the edge of the clock into which the data is strobed in by the peripheral.

Of the rise and fall times on the I2C, the slowest slew rate was the *rise* time shown in this digital oscilloscope capture, which is well within the acceptable time for the clocking rate!
