UI Board Test & Trouble Shooting

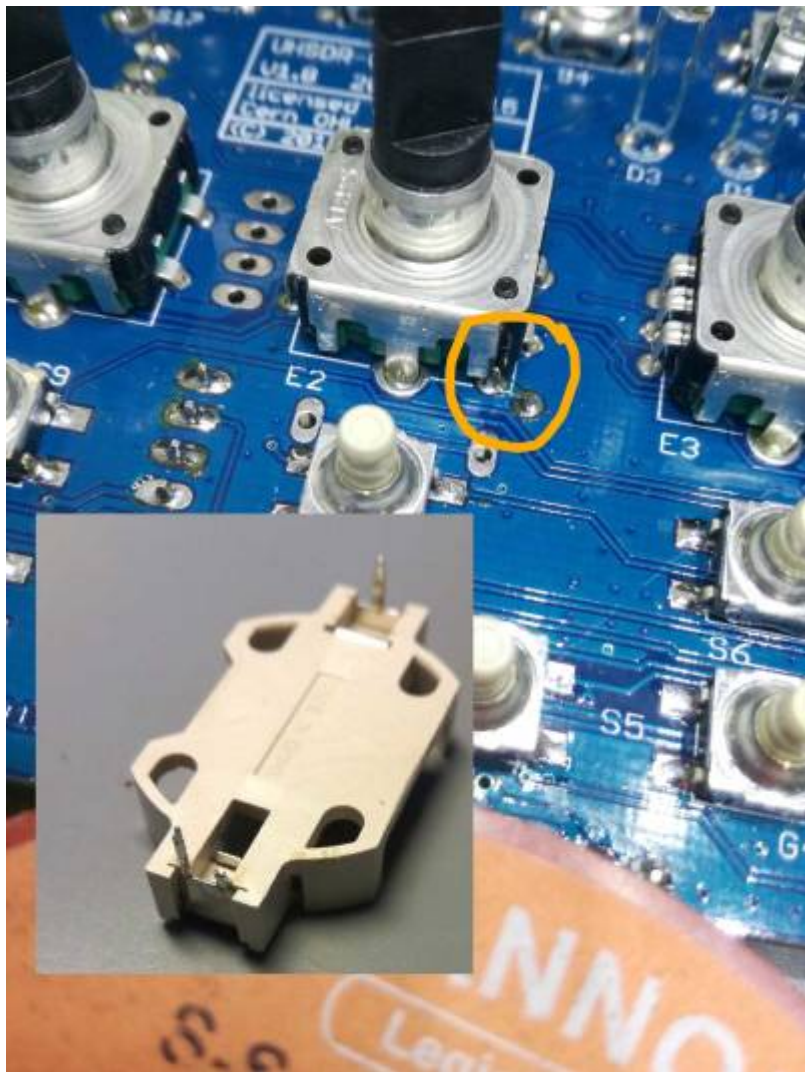
Potential short cut next to battery holder

Potential Shortcut (photo DF9EH)

Note: Also ganz wichtig: Wie auf dem Bild zu sehen unbedingt den einen Anschlußpin vor dem Einbau kürzen/abschneiden.

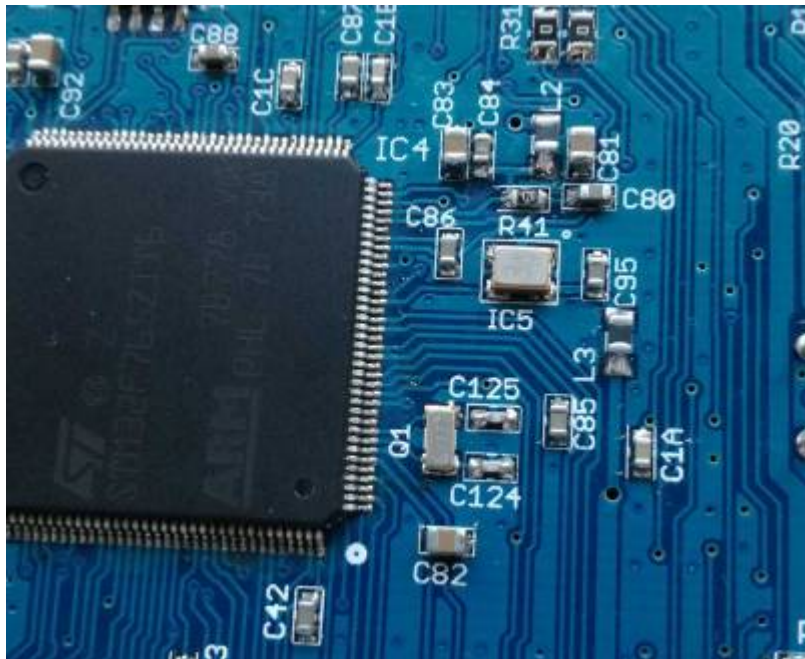
Attention: STM32 MCU Pin1 Mark

The MCU seems to have two (!) pin 1 marks. Watch text orientation on MCU to find „real“ pin 1.

Orientation of TXCO & MCU (photo DF9EH)

- RTC clock crystal and TXCO are prerequisite for flash programming to work
- Check correct orientation of TXCO (see photo on this page)
- Check 3.3V at C95. If not present then L3 may be defective
