## UI Board Test & Trouble Shooting

From:  
<https://www.amateurfunk-sulingen.de/wiki/> - Afu - Wiki des DARC OV Sulingen I40

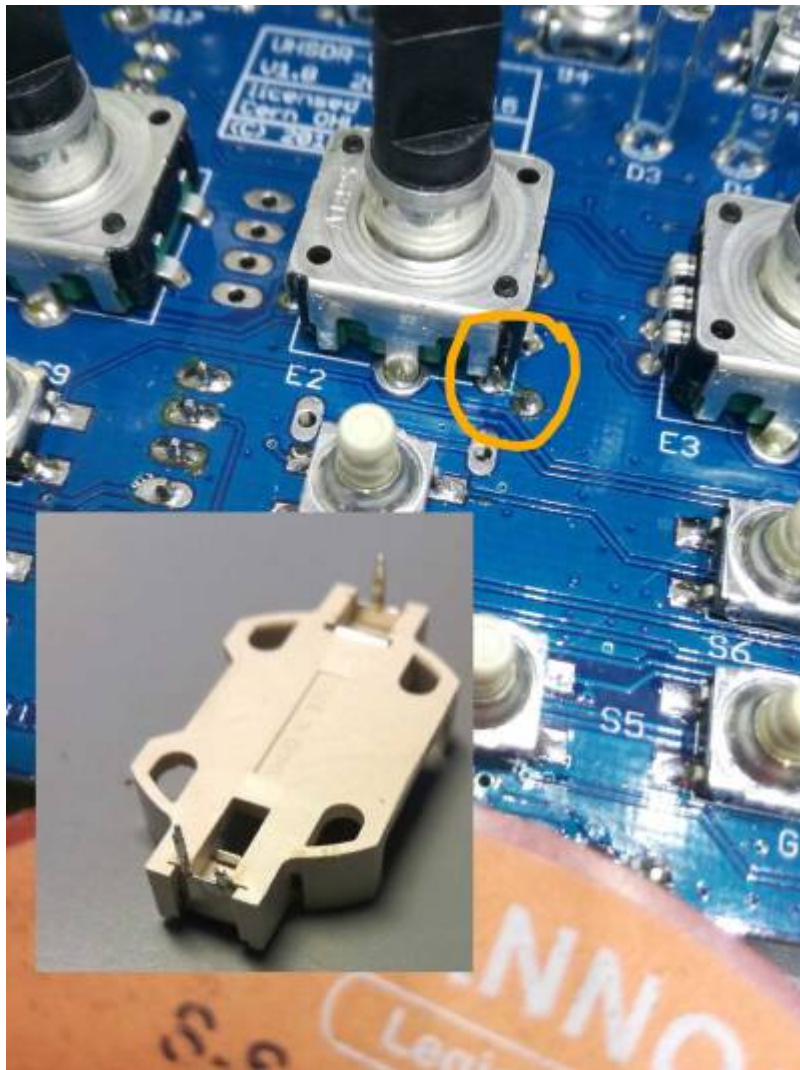
### Potential short cut next to battery holder

Potential Shortcut (photo DF9EH)

Note: Also ganz wichtig: Wie auf dem Bild zu sehen unbedingt den einen Anschlußpin vor dem Einbau kürzen/abschneiden.
