## UI Board Test & Trouble Shooting

From:  
<https://www.amateurfunk-sulingen.de/wiki/> - Afu - Wiki des DARC OV Sulingen I40

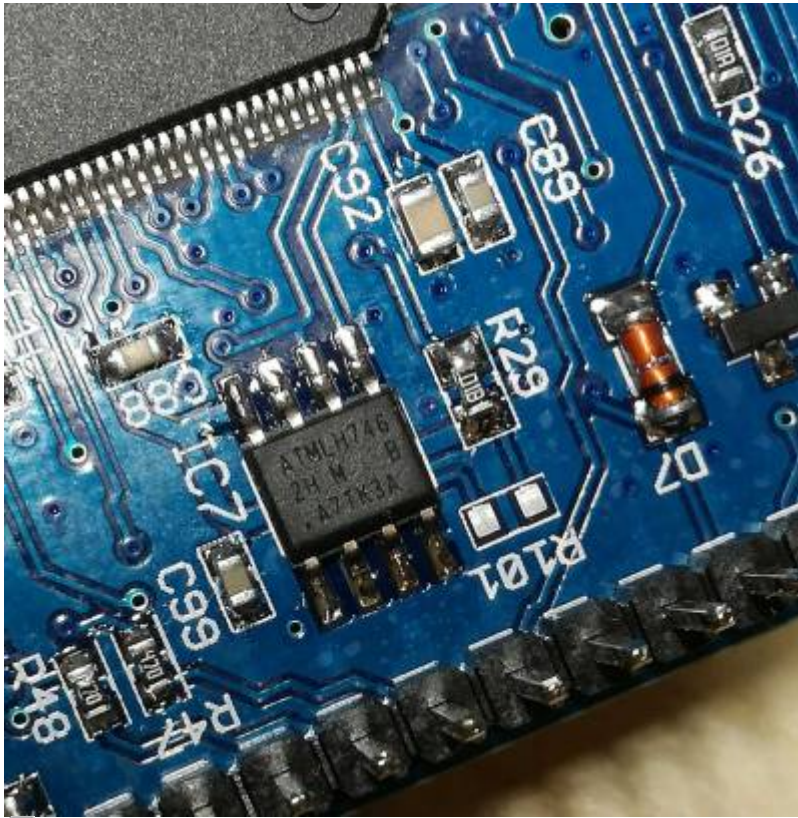
### EEPROM IC7 Pin 1 orientation

EEPROM IC7 position (photo DF9EH)

This is where the dot is printed. Also the edge of the case is slanted near the 1-4 pins. See [here](#)
