**mcHF Hardware modifications as of April 29, 2015
as compiled by KA7OEI for
Version 0.3/4 UI and Version 0.4 RF boards**

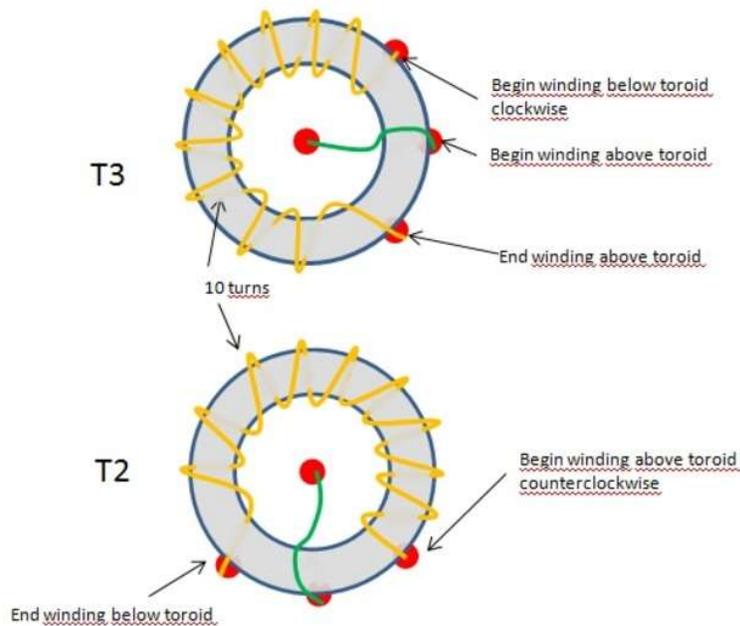
Winding details for T2 and T3

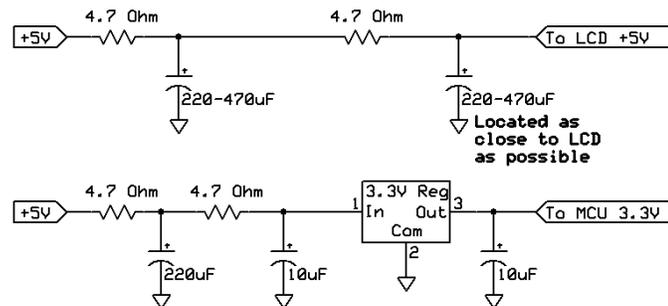
It was noted that when the above modification was completed that there was residual noise on the 5 volt line so further investigation was carried out. It turned out that the remainder of the noise was from two sources:

The diagram shows the filtering in schematic form. There is a voltage drop associated with each resistor, but each is well within the range of the associated device.

- The LCD has an internal 3.3 volt regulator that has a (worst-case) dropout voltage of 600mV – and less than 1 volt is dropped across the two 4.7 ohm resistors.
- The MCU regulator drops less than 250 mV per 4.7 ohm resistor, leaving well over a volt of headroom for the low-dropout regulator.

Note: Additional isolation will be obtained if the LCD, MCU and USB +5 volt supplies were derived from a separate 5 volt regulator on the UI board, powered from the +8 volt rail as depicted below.
