UHSDR Troubleshooting

MCU "bricked"

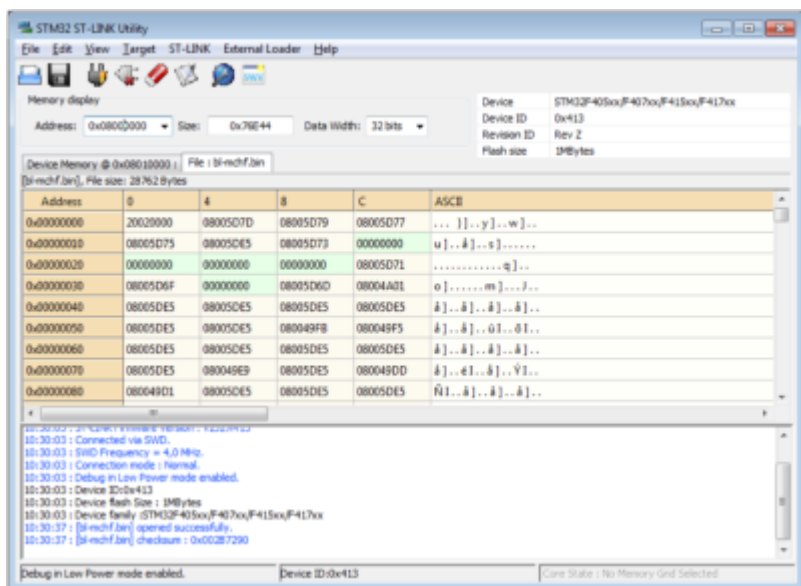
- SW Utility: Target→Connect
- SW Utility: File → Open (select the right .bin file, see above). The following screen should appear: (example shows mchF boot loader)
