UHSDR Troubleshooting

MCU "bricked"

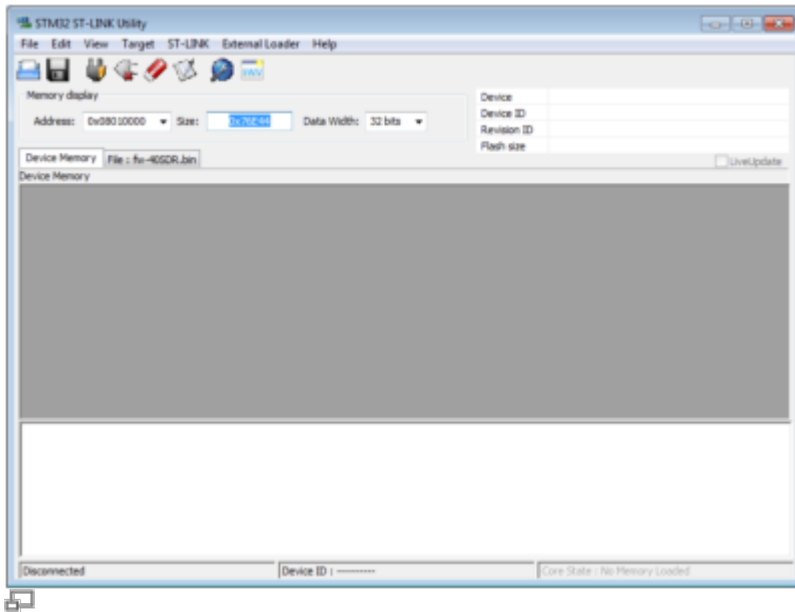
- Connect ST-Link/V2 with PC via USB cable
- SW Utility: ST-Link→Firmware update
- Check on PC screen in status messages that MCU is recognized correctly

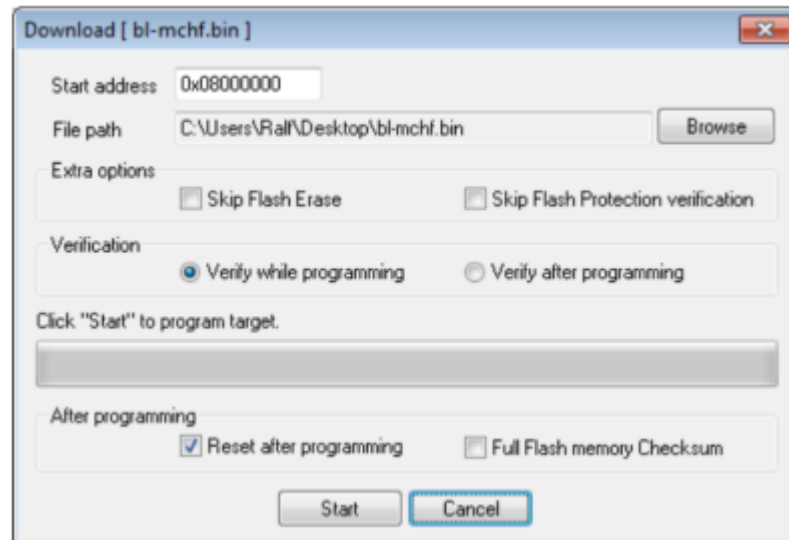
- Write the .bin file onto MCU with Target → Program & Verify
- In the subsequent window enter start address:
 - start address for boot loader: 0x08000000
- Then hit start button to program MCU

Für den Bootloader: 0x08000000

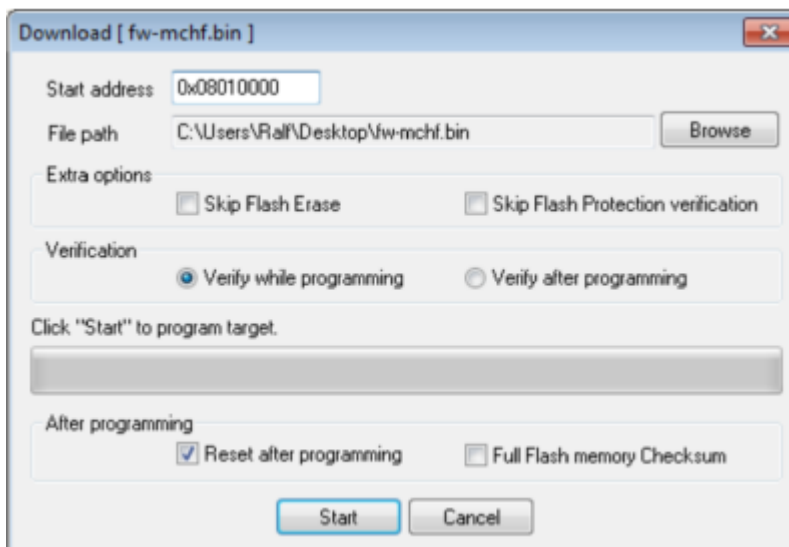
- Then program firmware in the same manner.
 - start address for firm ware would be 0x08010000
