UHSDR Troubleshooting

LCD constant white screen

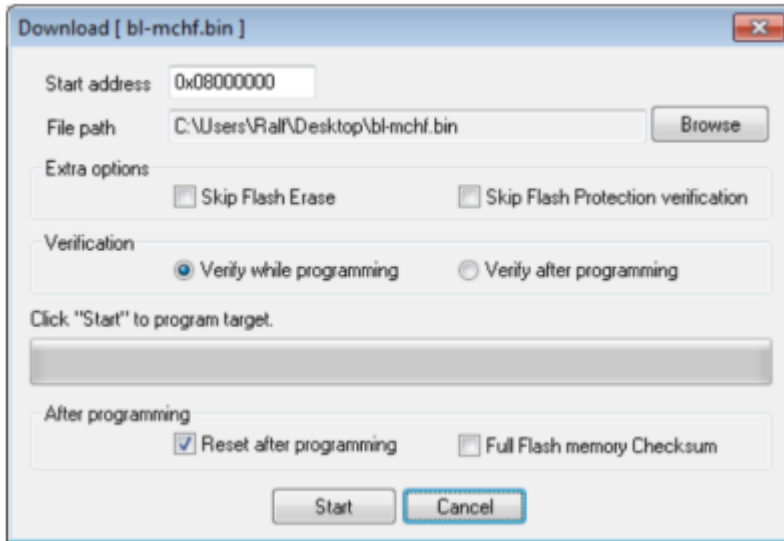
- Write the .bin file onto MCU with Target → Program & Verify
- In the subsequent window enter start address:
 - start address for boot loader: 0x08000000
- Then hit start button to program MCU

Für den Bootloader: 0x08000000

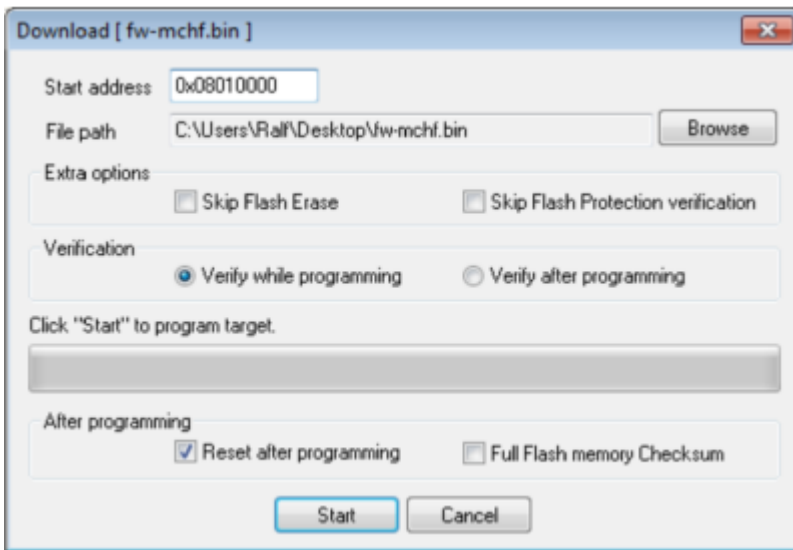
- Then program firmware in the same manner.
 - start address for firm ware would be 0x08010000
