UHSDR Troubleshooting

MCU "bricked"

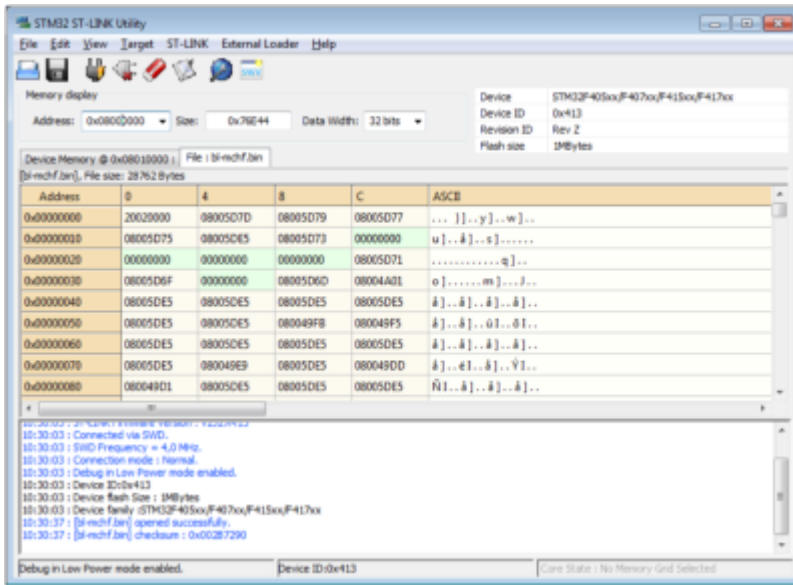
- SW Utility: Target→Connect
- SW Utility: File → Open (select the right .bin file, see above). The following screen should appear: (example shows mCHF boot loader)

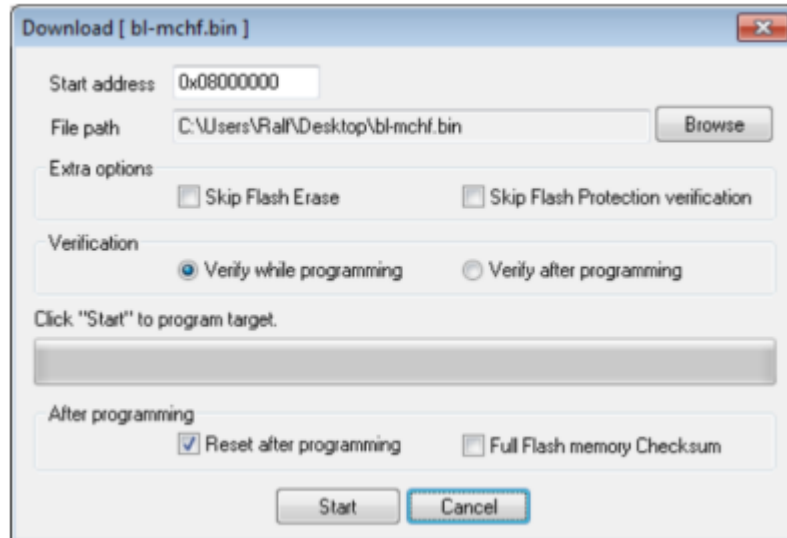
- Write the .bin file onto MCU with Target → Program & Verify
- In the subsequent window enter start address:
 - start address for boot loader: 0x08000000
- Then hit start button to program MCU

Für den Bootloader: 0x08000000

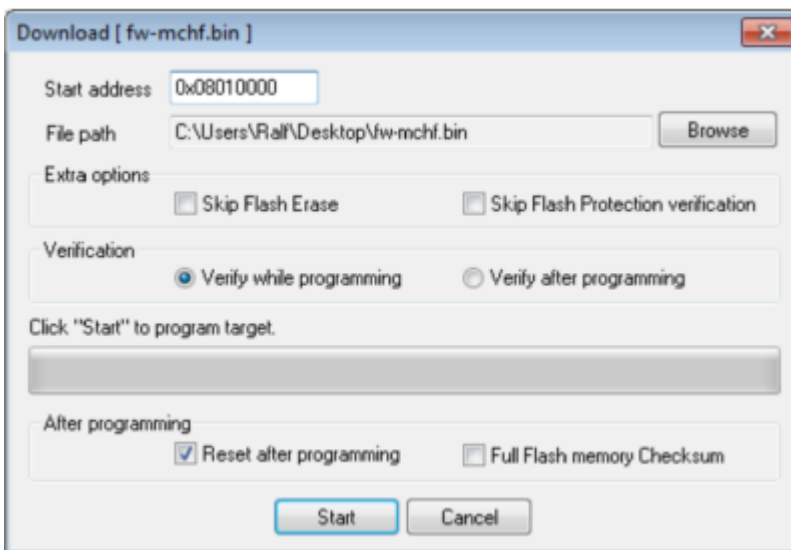
- Then program firmware in the same manner.
 - start address for firm ware would be 0x08010000
