UHSDR Troubleshooting

LCD constant white screen

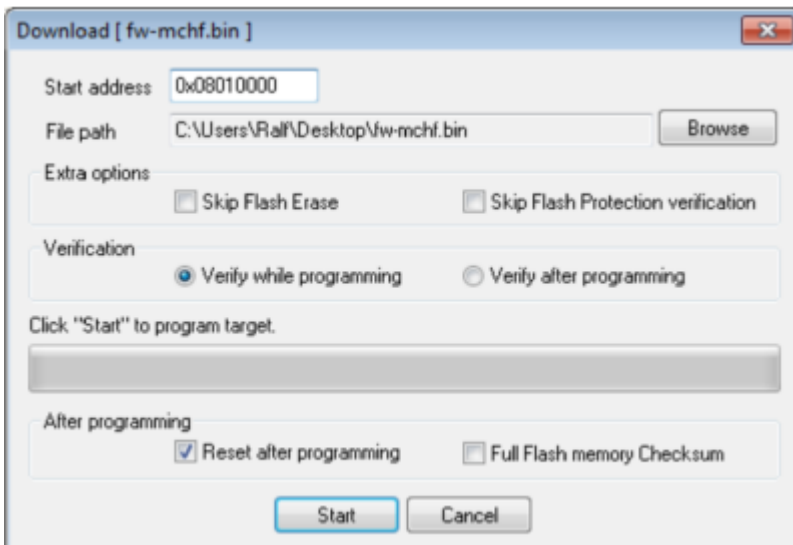
- Then program firmware in the same manner.
 - start address for firm ware would be 0x08010000
