UHSDR Troubleshooting

LCD constant white screen

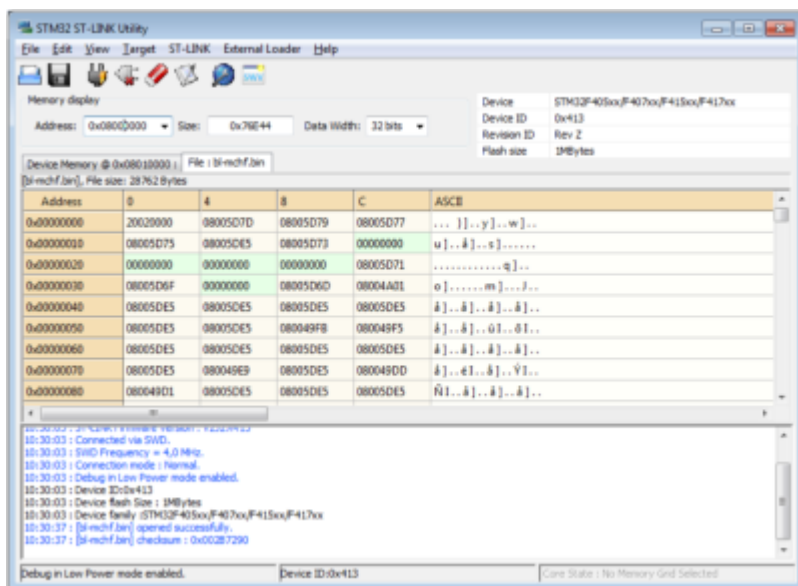
- SW Utility: Target→Connect
- SW Utility: File → Open (select the right .bin file, see above). The following screen should appear: (example shows mchF boot loader)
