UHSDR Troubleshooting

MCU "bricked"

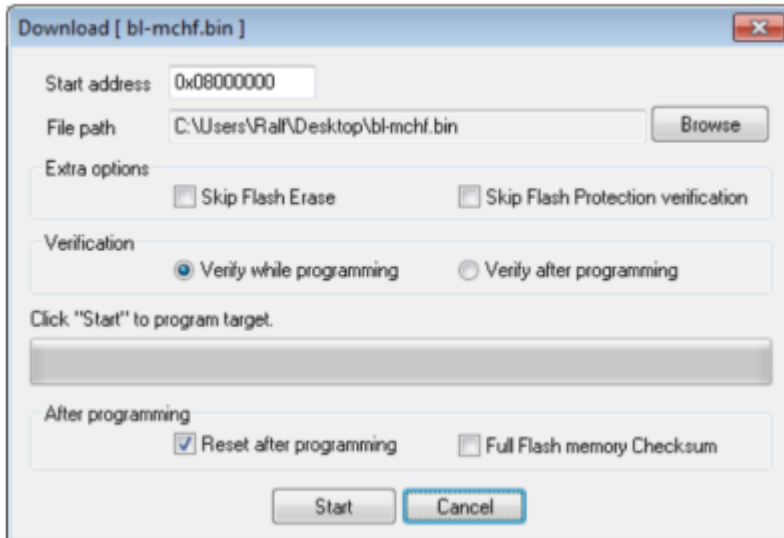
- Write the .bin file onto MCU with Target → Program & Verify
- In the subsequent window enter start address:
 - start address for boot loader: 0x08000000
- Then hit start button to program MCU

Für den Bootloader: 0x08000000
