UHSDR Troubleshooting

MCU "bricked"

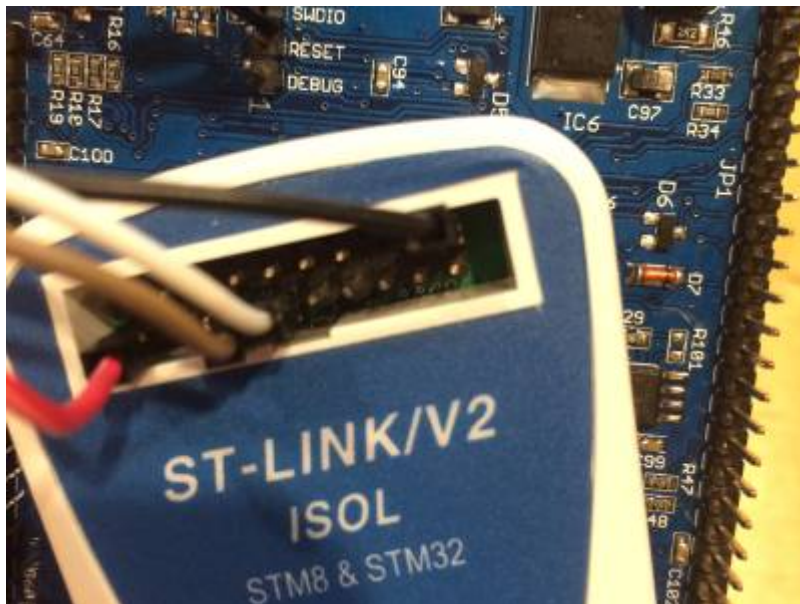
ST-link adapter	OVI40 UI JP8	Remark
Pin-13 TRACESWO	JP8 Pin 1	Debug Output
Pin-15 NRST	JP8 Pin 2	Reset
Pin-07 SWDIO	JP8 Pin 3	Debug I/O
Pin-09 SWCLK	JP8 Pin 4	Debug Clock
Pin-01 MCU VDD	JP8 Pin 5	VDD from MCU
Pin-20 Gnd	JP8 Pin 6	Ground

Connection ST-Link to UI board (photo F4HTX)

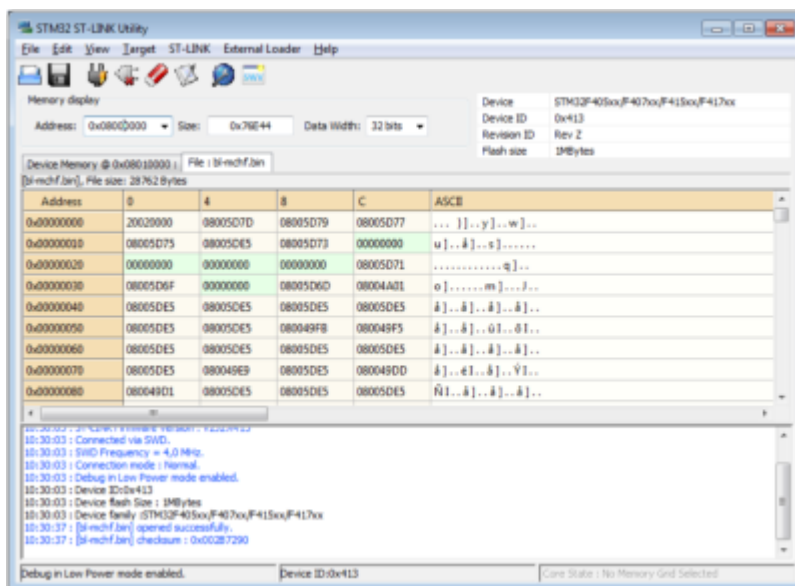
- SW Utility: Target→Connect
- SW Utility: File → Open (select the right .bin file, see above). The following screen should appear: (example shows mchF boot loader)

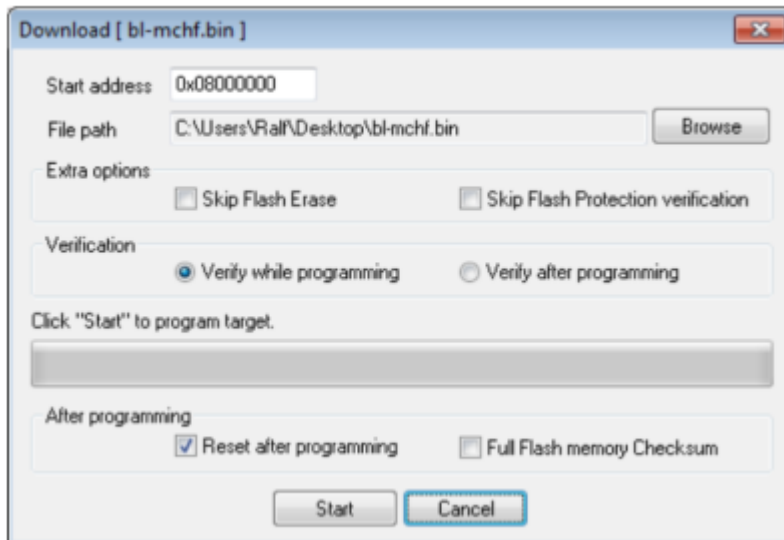
- Write the .bin file onto MCU with Target → Program & Verify
- In the subsequent window enter start address:
 - start address for boot loader: 0x08000000
- Then hit start button to program MCU

Für den Bootloader: 0x08000000

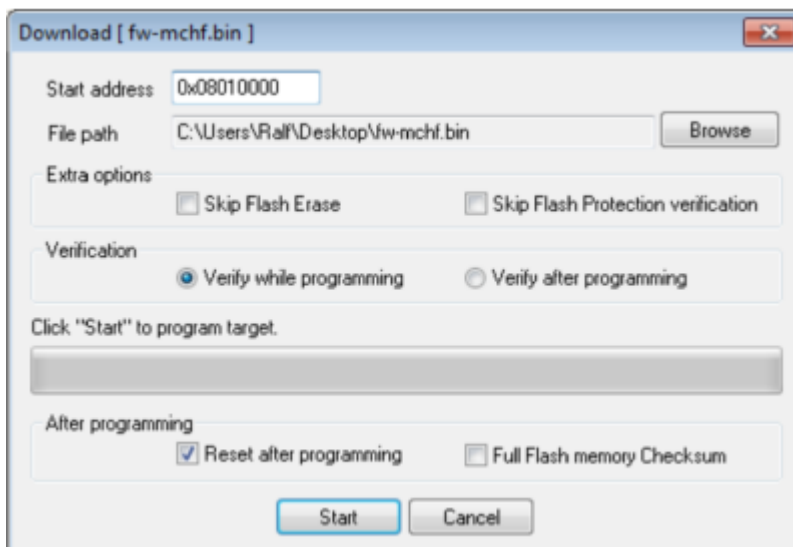
- Then program firmware in the same manner.
 - start address for firm ware would be 0x08010000
