# UHSDR Troubleshooting

## LCD constant white screen

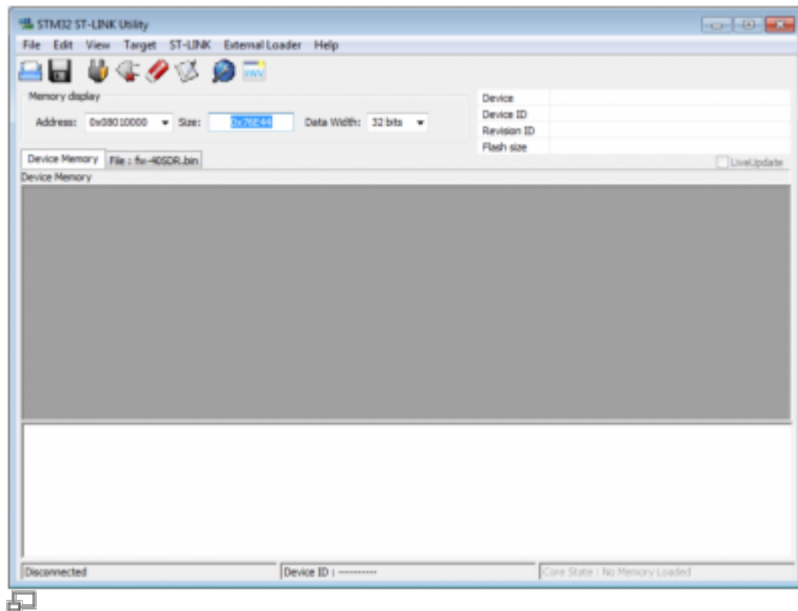
- Connect ST-Link/V2 with PC via USB cable
- SW Utility: ST-Link→Firmware update
- Check on PC screen in status messages that MCU is recognized correctly

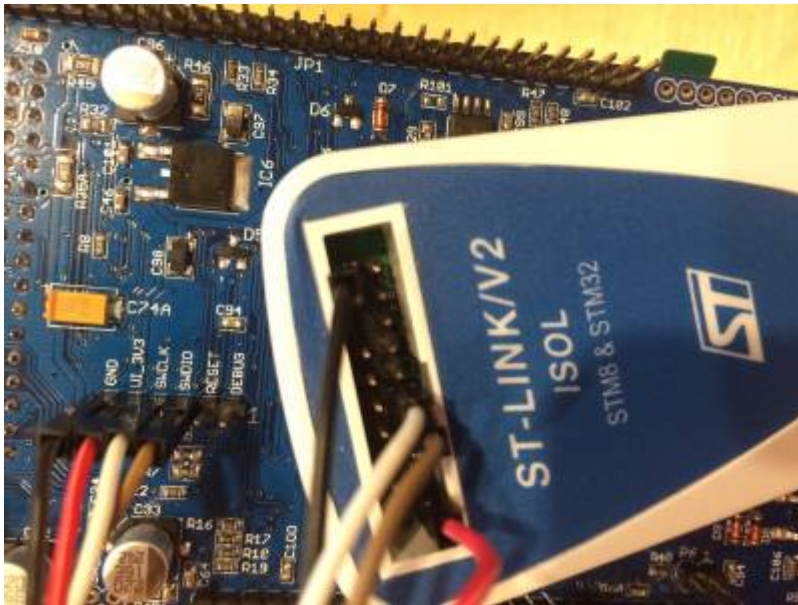
ST-link adapter	OVI40 UI JP8	Remark
Pin-13 TRACESWO	JP8 Pin 1	Debug Output
Pin-15 NRST	JP8 Pin 2	Reset
Pin-07 SWDIO	JP8 Pin 3	Debug I/O
Pin-09 SWCLK	JP8 Pin 4	Debug Clock
Pin-01 MCU VDD	JP8 Pin 5	VDD from MCU
Pin-20 Gnd	JP8 Pin 6	Ground

Connection ST-Link to UI board (photo F4HTX)

The debug cable shouldn't be longer than 10 cm. 3 to 4 connections are needed.

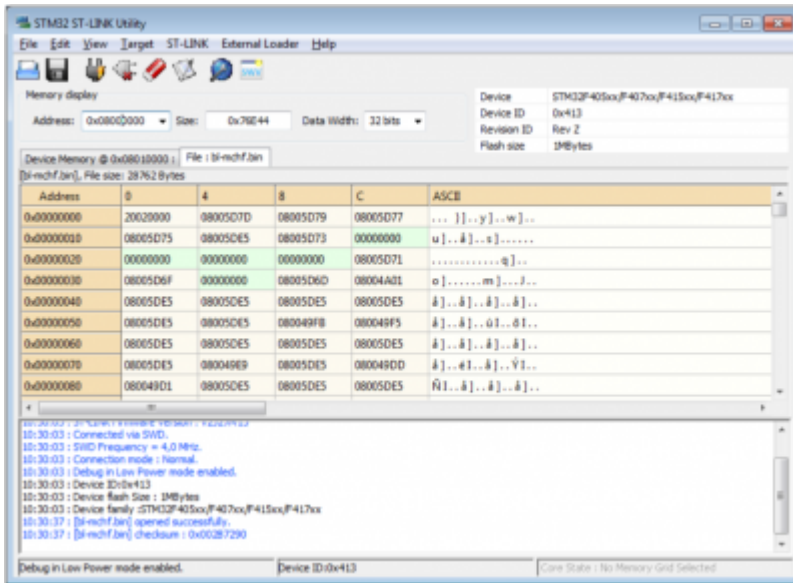
- SW Utility: Target→Connect
- SW Utility: File → Open (select the right .bin file, see above). The following screen should appear: (example shows mchF boot loader)

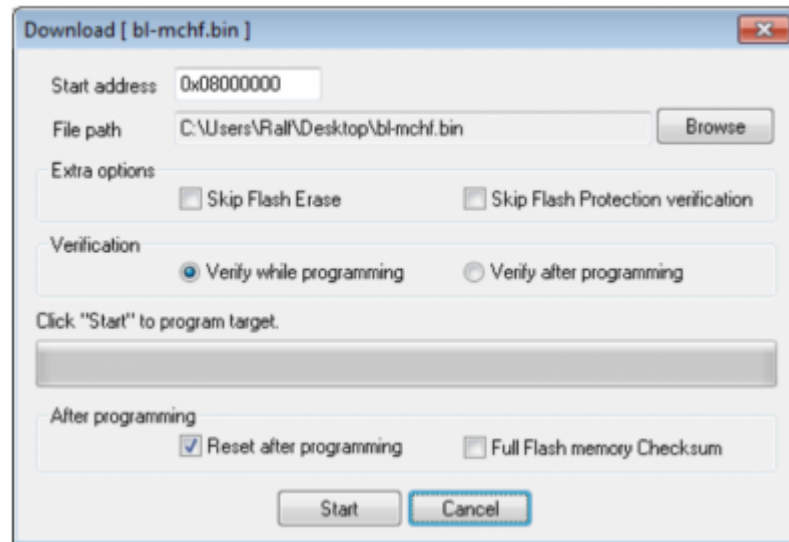
## Für den Bootloader: 0x08000000

- Write the .bin file onto MCU with Target → Program & Verify
- In the subsequent window enter start address:
  - start address for boot loader: 0x08000000
- Then hit start button to program MCU

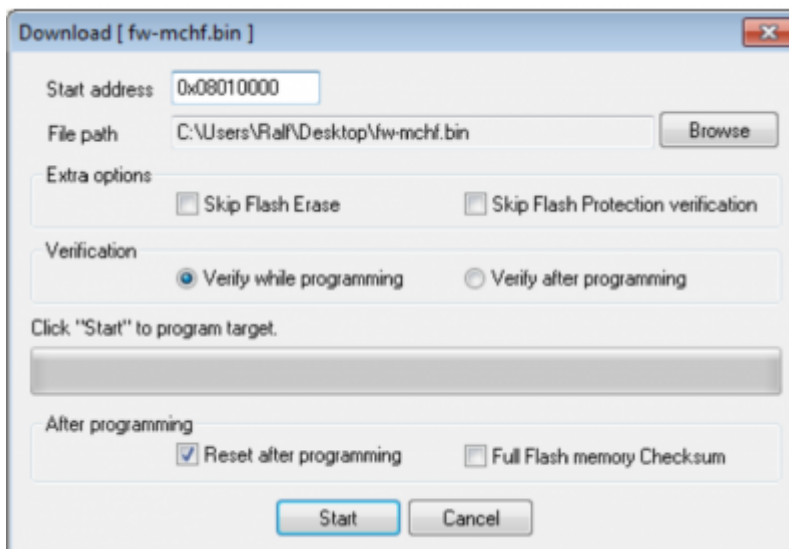
- Then program firmware in the same manner.
  - start address for firm ware would be 0x08010000

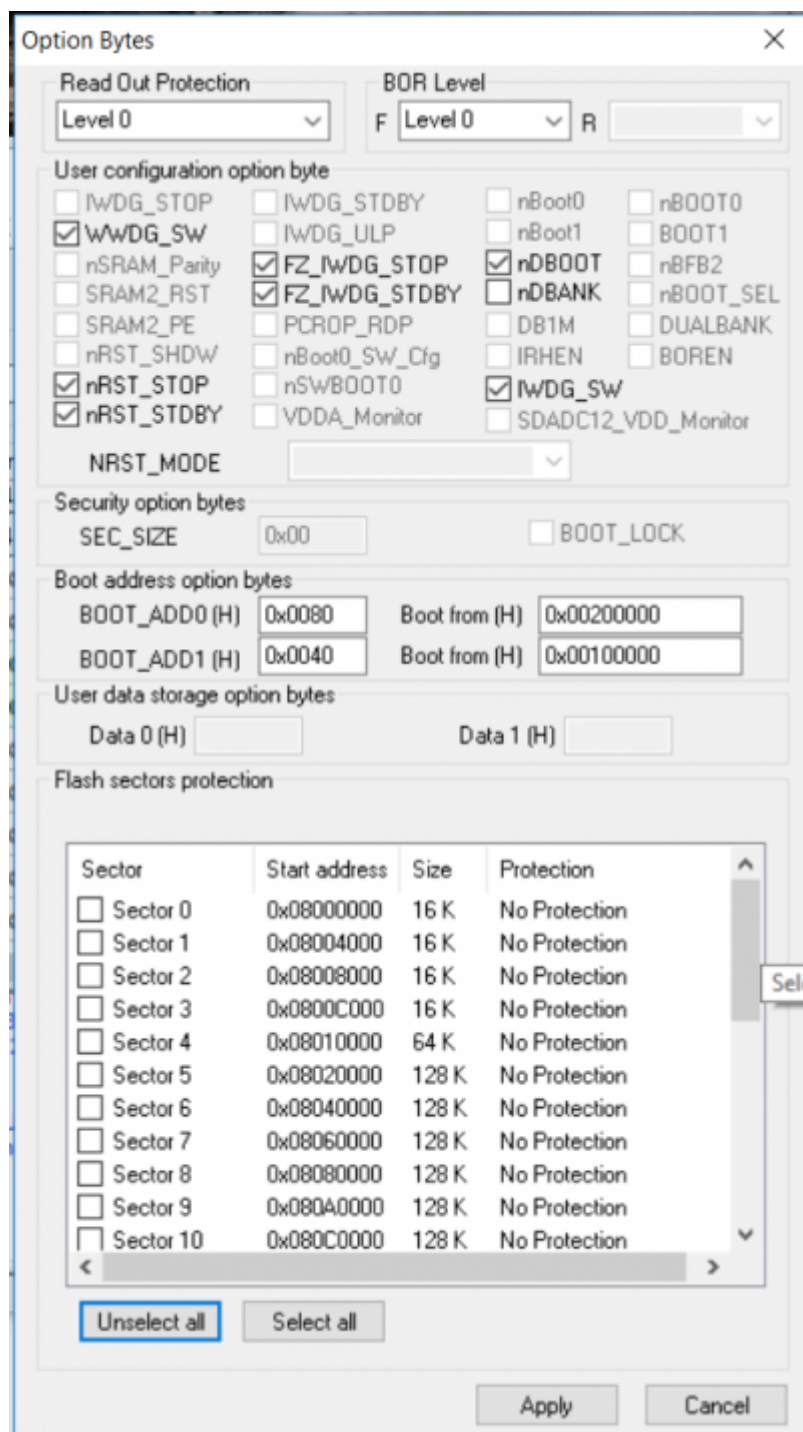
4. If ok in SW tool click Target→MCU Core to display MCU option bytes.

Option Bytes values STM32F767ZI (screenshot DF9TS)
