UHSDR Troubleshooting

LCD constant white screen

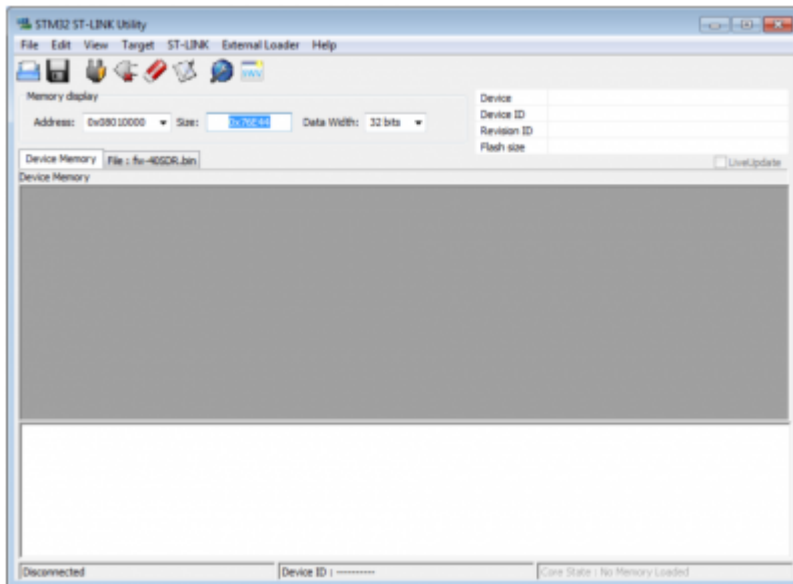
- Connect ST-Link/V2 with PC via USB cable
- SW Utility: ST-Link→Firmware update
- Check on PC screen in status messages that MCU is recognized correctly

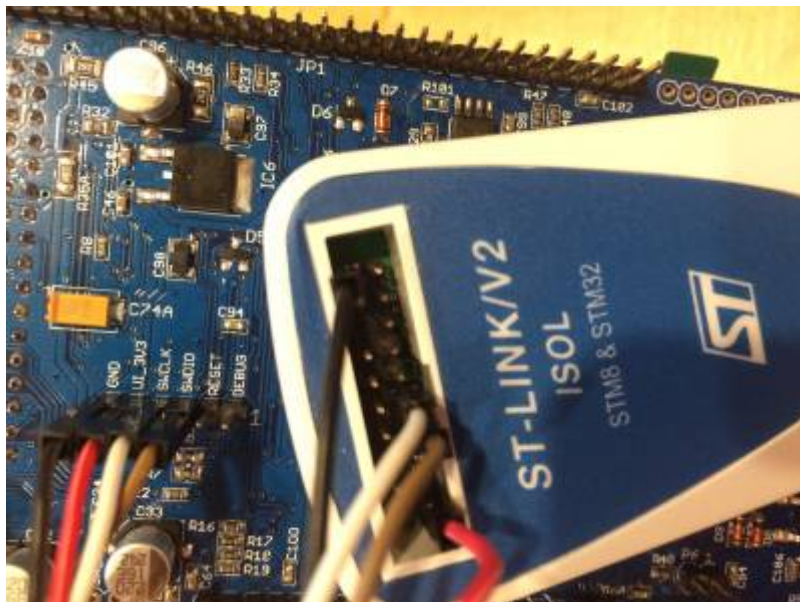
Connection ST-Link to UI board (photo F4HTX)

ST-link adapter	OVI40 UI JP8	Remark
Pin-13 TRACESWO	JP8 Pin 1	Debug Output
Pin-15 NRST	JP8 Pin 2	Reset
Pin-07 SWDIO	JP8 Pin 3	Debug I/O
Pin-09 SWCLK	JP8 Pin 4	Debug Clock
Pin-01 MCU VDD	JP8 Pin 5	VDD from MCU
Pin-20 Gnd	JP8 Pin 6	Ground

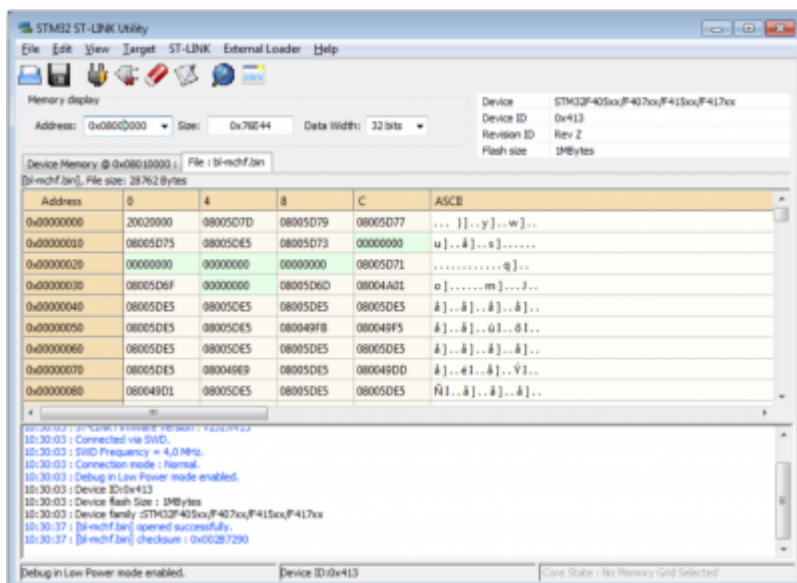
- SW Utility: Target→Connect
- SW Utility: File → Open (select the right .bin file, see above). The following screen should appear: (example shows mchF boot loader)

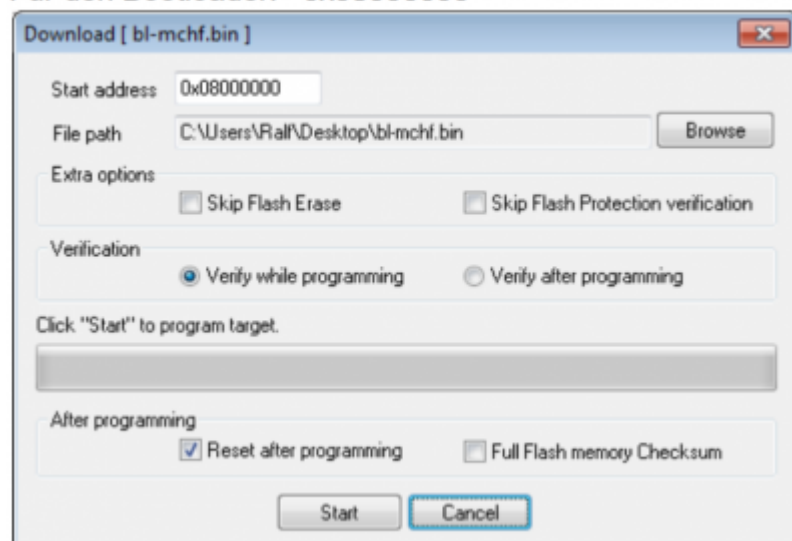
- Write the .bin file onto MCU with Target → Program & Verify
- In the subsequent window enter start address:
 - start address for boot loader: 0x08000000
- Then hit start button to program MCU

Für den Bootloader: 0x08000000

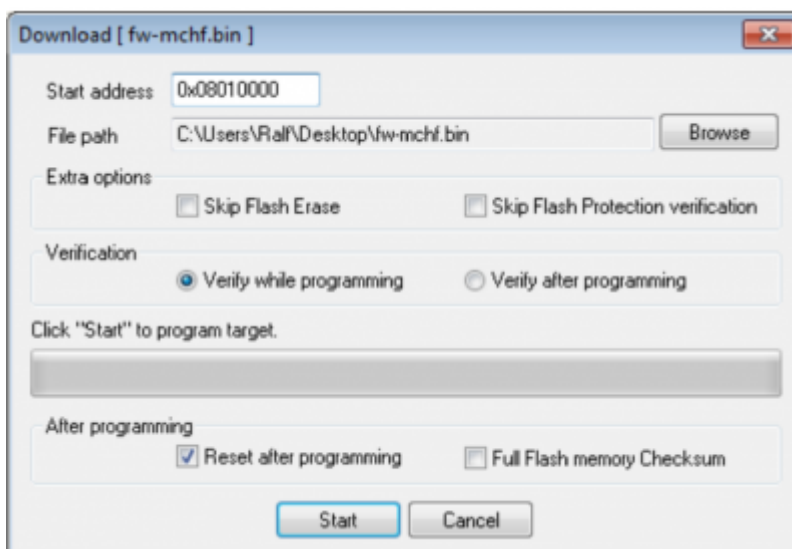
- Then program firmware in the same manner.
 - start address for firm ware would be 0x08010000

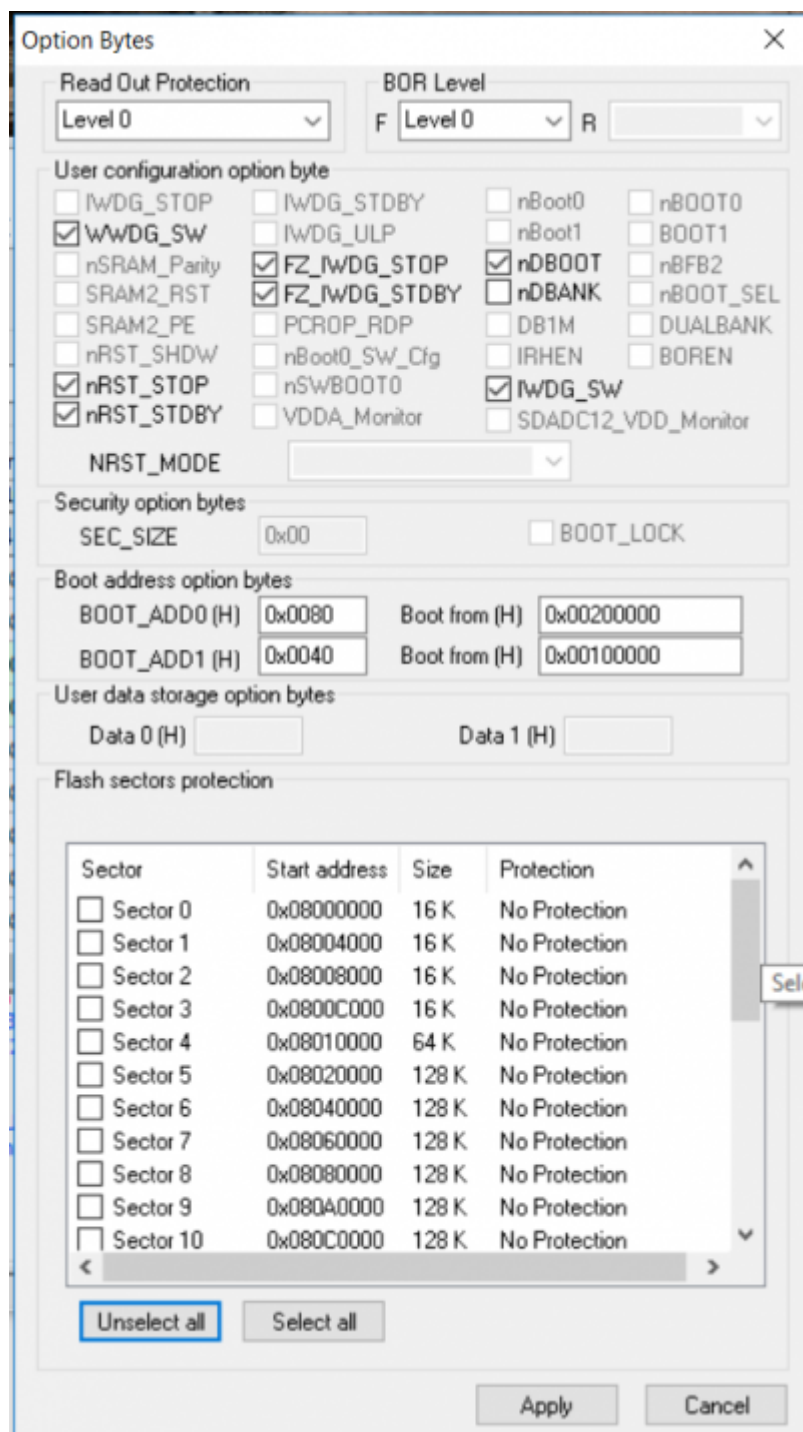
4. If ok in SW tool click Target→MCU Core to display MCU option bytes.

Option Bytes values STM32F767ZI (screenshot DF9TS)
