# UHSDR Troubleshooting

## LCD constant white screen

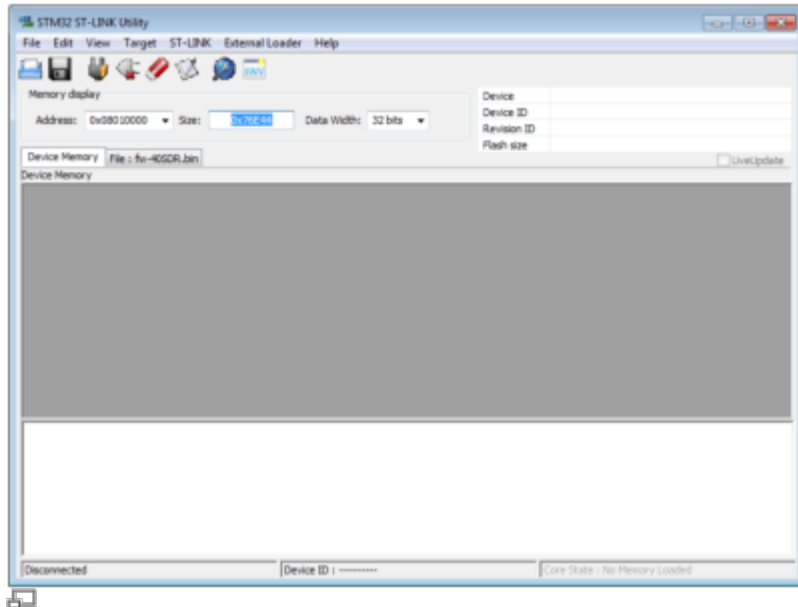
- Connect ST-Link/V2 with PC via USB cable
- SW Utility: ST-Link→Firmware update
- Check on PC screen in status messages that MCU is reackognized correctly

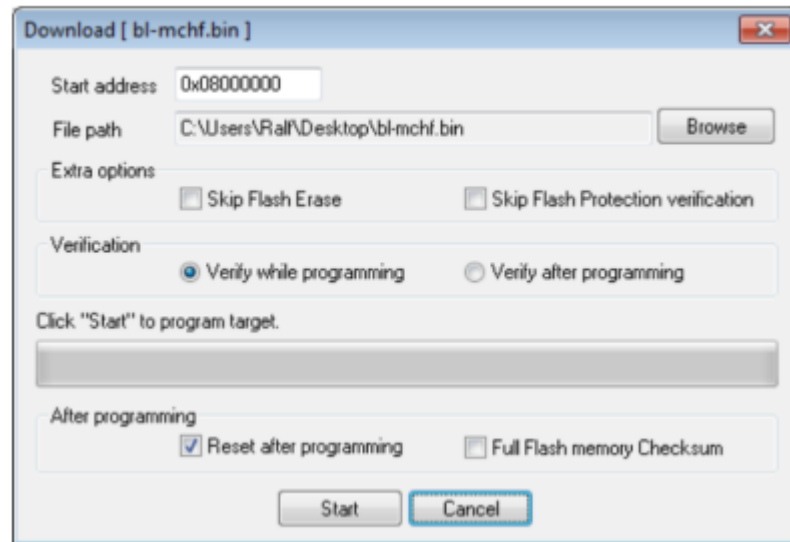
## Für den Bootloader: 0x08000000

- Write the .bin file onto MCU with Target → Program & Verify
- In the subsequent window enter start address:
  - start address for boot loader: 0x08000000
- Then hit start button to program MCU

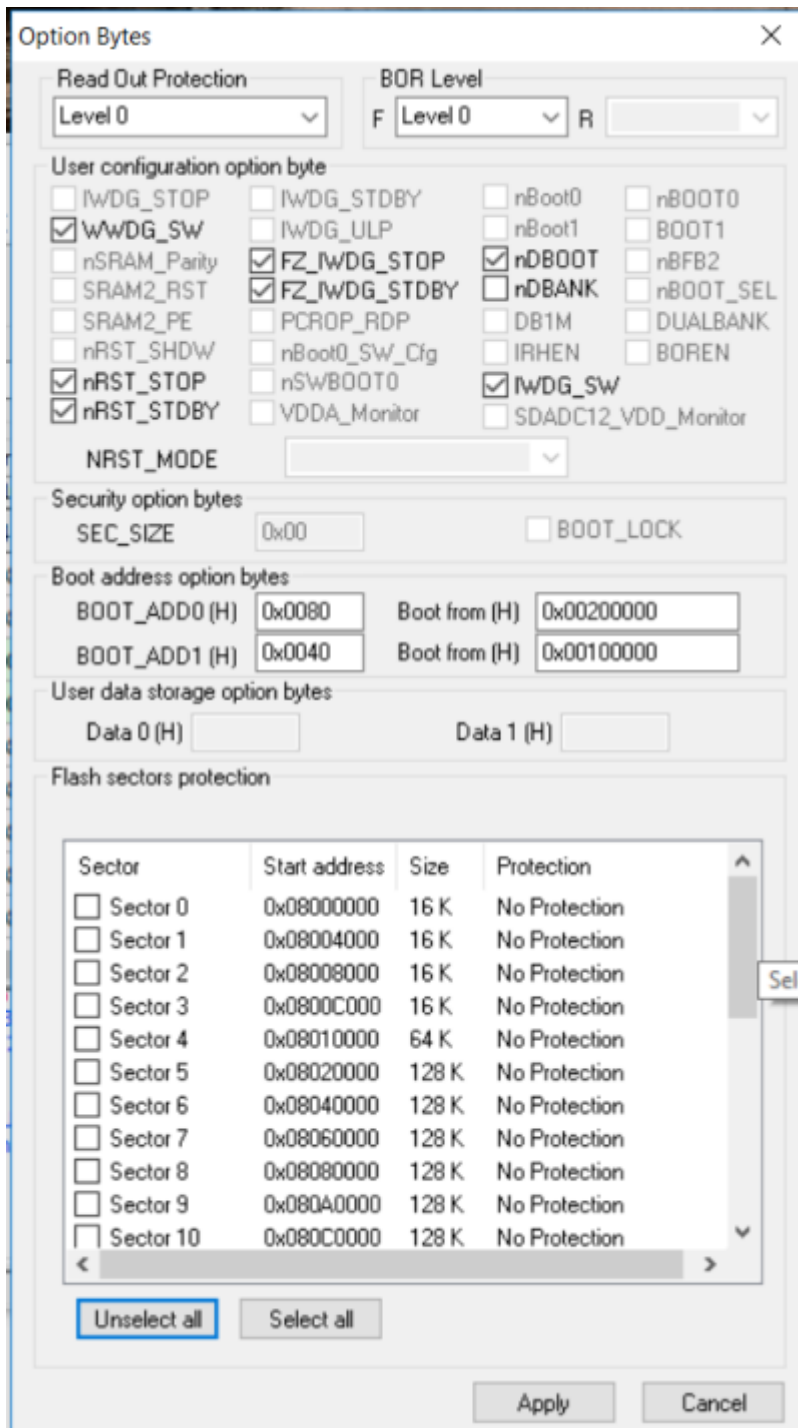
Option Bytes values STM32F767ZI (screenshot DF9TS)

Read Out Protection:	Level0
BOR-Level:	Level3
IWDG_SW:	gesetzt
WWDG_SW:	gesetzt
nRST_STOP:	gesetzt
nRST_STDBY:	gesetzt

FZ_IWDG_STOP:	gesetzt
FZ_IWDG_STDBY:	gesetzt
nDBOOT:	gesetzt
nDBANK:	nicht gesetzt
BOOT_ADD0:	0x0080 Boot from 0x200000
BOOT_ADD1:	0x0040 Boot from 0x100000
No ticks set at all in any box below „Flash Section Protection“

4. If ok in SW tool click Target→MCU Core to display MCU option bytes.
