# UHSDR Troubleshooting

From: <https://www.amateurfunk-sulingen.de/wiki/> - Afu - Wiki des DARC OV Sulingen I40

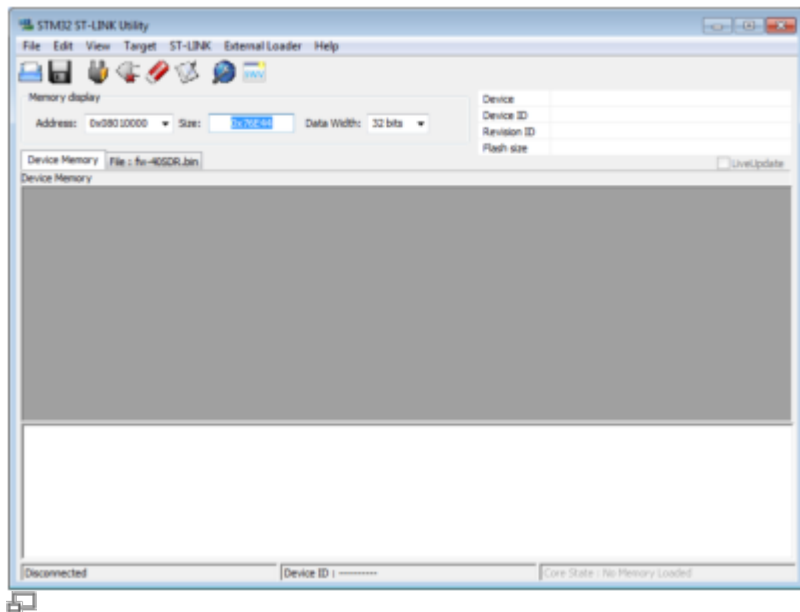
- Connect ST-Link/V2 with PC via USB cable
- SW Utility: ST-Link→Firmware update
- Check on PC screen in status messages that MCU is recognized correctly
